DEPARTMENT OF TRANSPORTATION**DIVISION OF ENGINEERING SERVICES**

Contract #: 04-0120F4Cty: SF/ALA Rte: 80 PM: 13.2/13.9File #: 69.28**WELDING INSPECTION REPORT****Resident Engineer:** Pursell, Gary**Address:** 333 Burma Road**City:** Oakland, CA 94607**Report No:** WIR-014952**Date Inspected:** 14-Jun-2010**Project Name:** SAS Superstructure**OSM Arrival Time:** 700**Prime Contractor:** American Bridge/Fluor Enterprises, a JV**OSM Departure Time:** 1900**Contractor:** Zhenhua Port Machinery Company, Ltd (ZPMC), Changxing Island **Location:** Shanghai, China**CWI Name:** ZPMC and ABF**CWI Present:** Yes No**Inspected CWI report:** Yes No N/A**Rod Oven in Use:** Yes No N/A**Electrode to specification:** Yes No N/A**Weld Procedures Followed:** Yes No N/A**Qualified Welders:** Yes No N/A**Verified Joint Fit-up:** Yes No N/A**Approved Drawings:** Yes No N/A**Approved WPS:** Yes No N/A**Delayed / Cancelled:** Yes No N/A**Bridge No:** 34-0006**Component:** Tower**Summary of Items Observed:**

Tower heavy dock

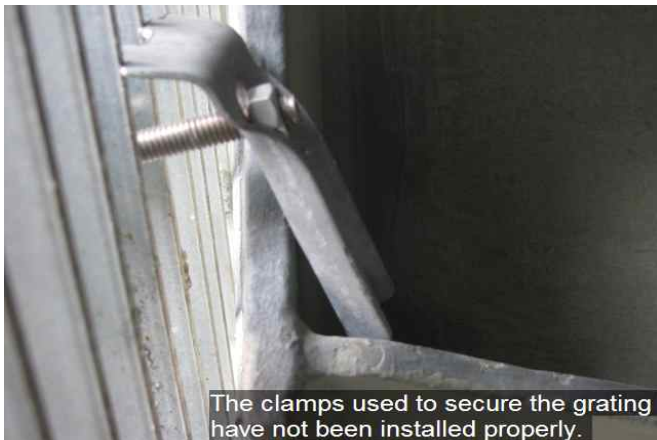
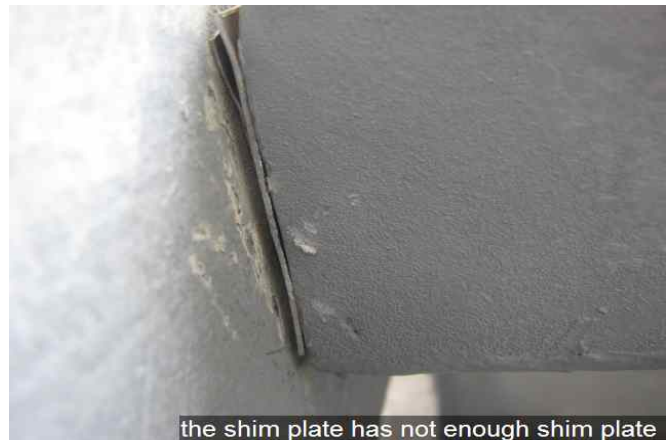
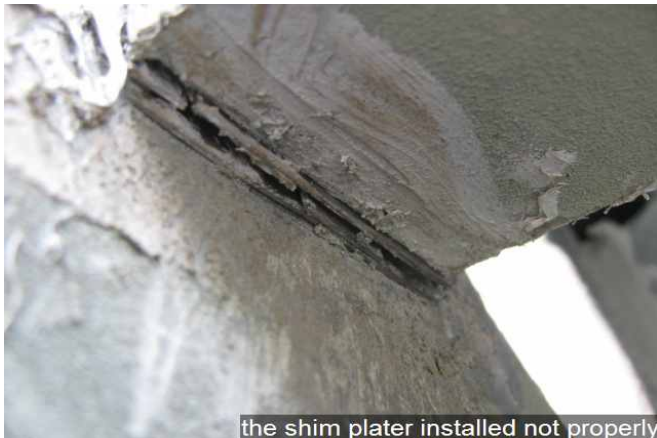
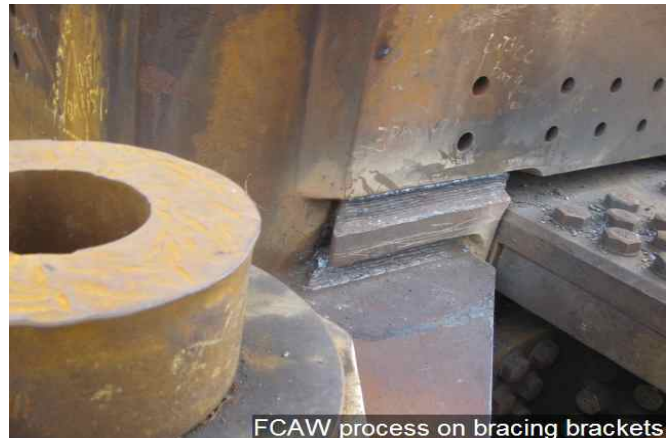
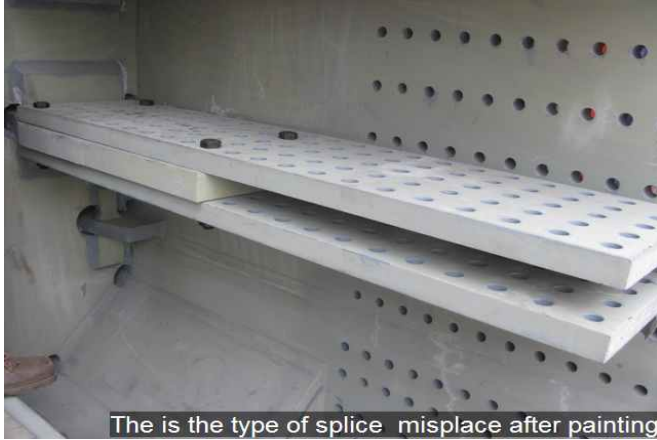
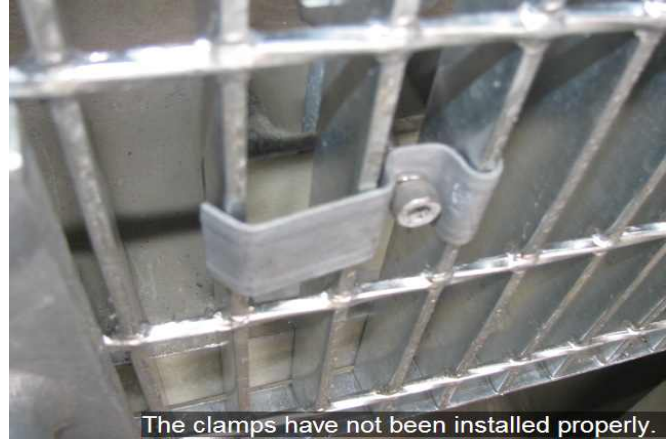
Caltrans QA inspector observed six ZPMC workers in process of FCAW CJP welding on the cross bracing brackets. The cross bracing brackets is located at the elevation 65m and 77m diaphragm sections that connected to skin plate A and B of north, east, south and west tower lift #2. The FCAW process was monitored and recorded by ZPMC and ABF QC inspector. Based on Caltrans QAI observations, no discrepancies were noted.

1st issue: The ZPMC workers installed the shim plates to the open gaps between the base plates to external and internal side bearing stiffeners after moved to the vassal. The bearing stiffeners located on A, B, C, D and E skin plates of west and north tower lift #1. The shim plate size has 0.5mm and 1mm. Some of open gap has found the shim plate has not enough shim plate or installed not properly. Also, few open gap areas have been caulked before Caltrans QA inspection. Caltrans QA informed ZPMC QC that shim plate areas have been accepted by Caltrans prior caulking. The open gap issue has been filed a NCR #0708 on 5-30-10.

2nd issue: The clamps used to secure the grating have not been installed properly. The gratings are located at elevation 9m thru 47.6m interior diaphragm of north, east, south, west tower lift#1. According to RFI 733 the clamp unit is fixed on the grating support and grating. However, the clamps installed on the grating seem not a suitable size attached the bracket and secured the grating. The bolt of the clamp will loose in the future.

3rd issue: The splices plate installed at the wrong direction or location after paint. This issue has been found by

ABF next week. ABF QC and Caltrans QA inspector have verified the splice this afternoon. However, 60% splice plate can't inspect due to lack of scaffolding. The following is the splice list after verifying.
